ATWOOD 8940-III ACLP UPGRADE

- 1989 Fleetwood Park Model
- Metal Siding
- 110 Volt, LP Gas Furnace

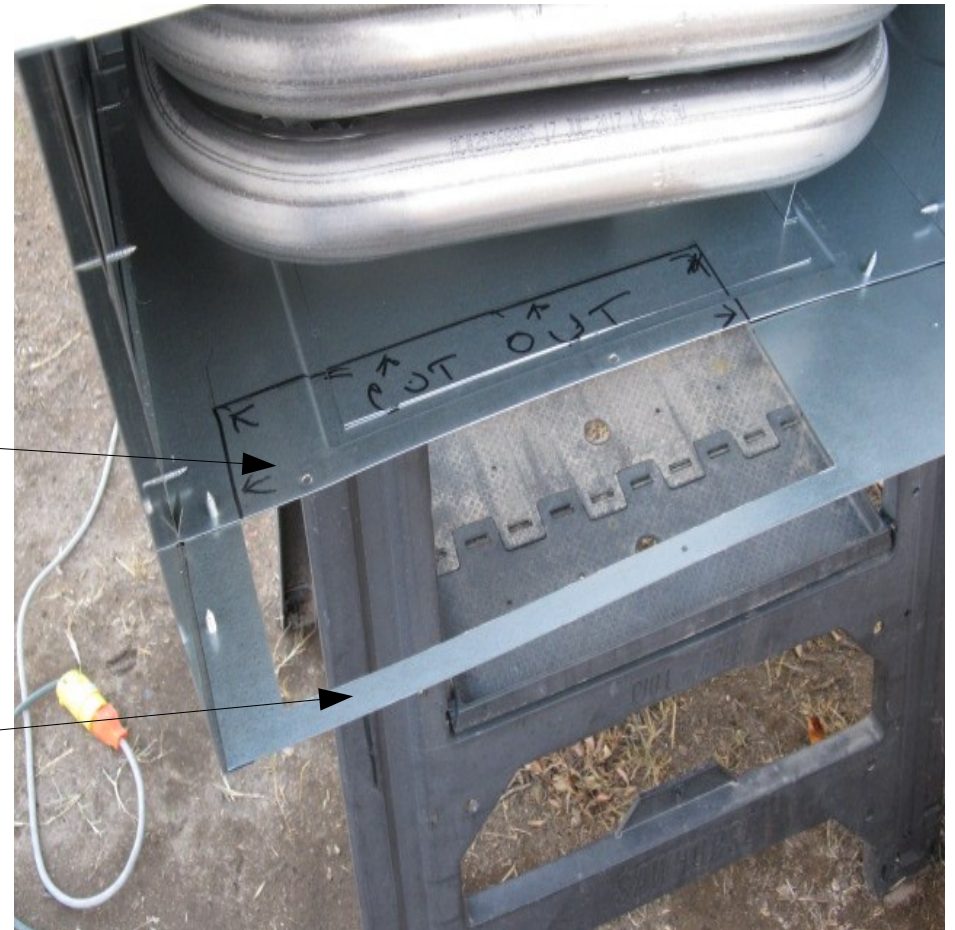
PREP NEW FURNACE

- Additional material must be removed from the main housing in order to end up with a 5"x 10" opening to match the old furnace opening.
- 32337 Discharge Kit is added after removing the back of the furnace housing.

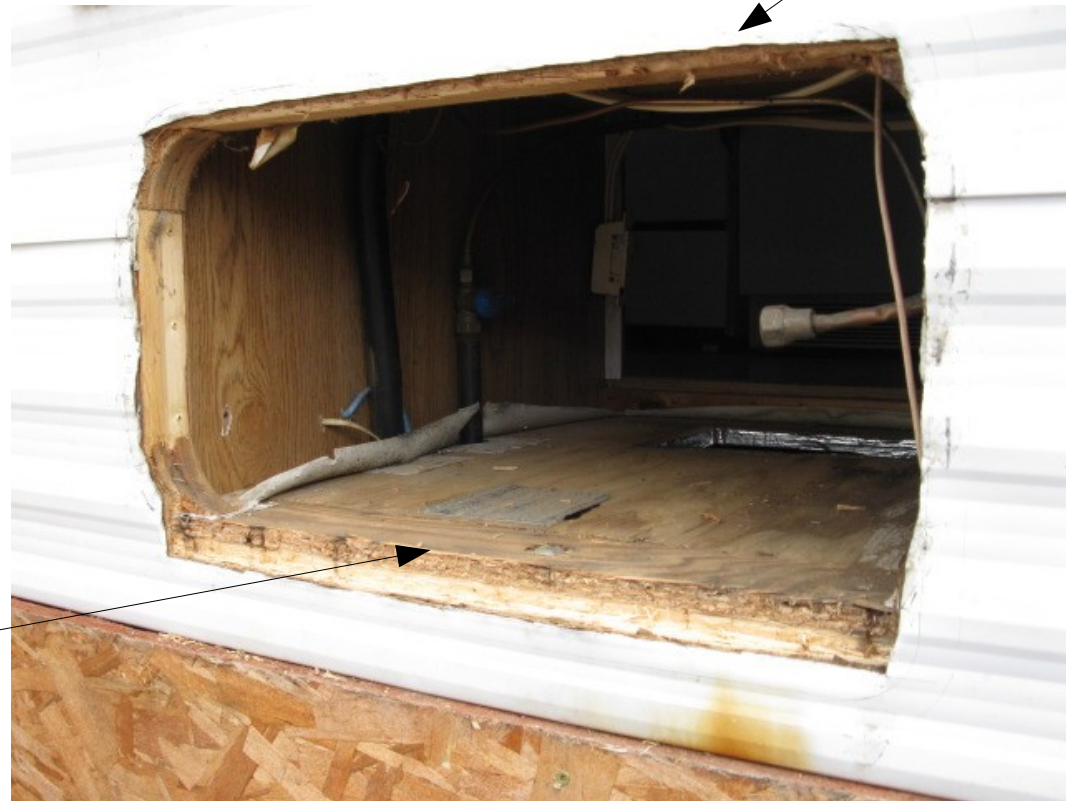
PREP SIDEWALL

- Opening must be enlarged to accommodate door bezel and its mount tabs.
- With furnace bottom flush with floor, saw or chisel out 1" high x 1/2" deep in the face of the bottom opening, to accommodate width of the bezel.
- Cut out approximately 1/8th inch on top.

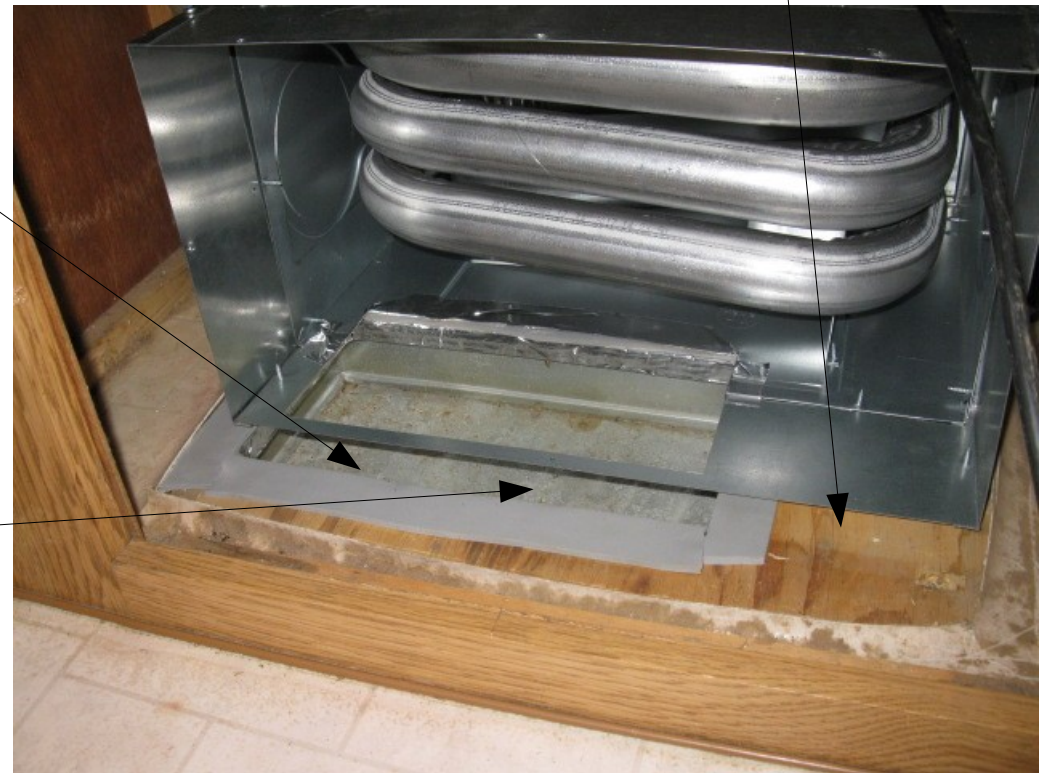
DESIGN FLAW?

- Furnace housing extends “into” bezel. Adding metal siding and trim ring makes housing about 1” short.
- Floor opening larger than furnace cut-out.
- Cover and seal with foil tape after replacing furnace-back or add plate to shortage opening and seal.
- 32337 Discharge Kit could be 1” wider to add 4” instead of just 3”.

- Lighter color where old furnace sat.

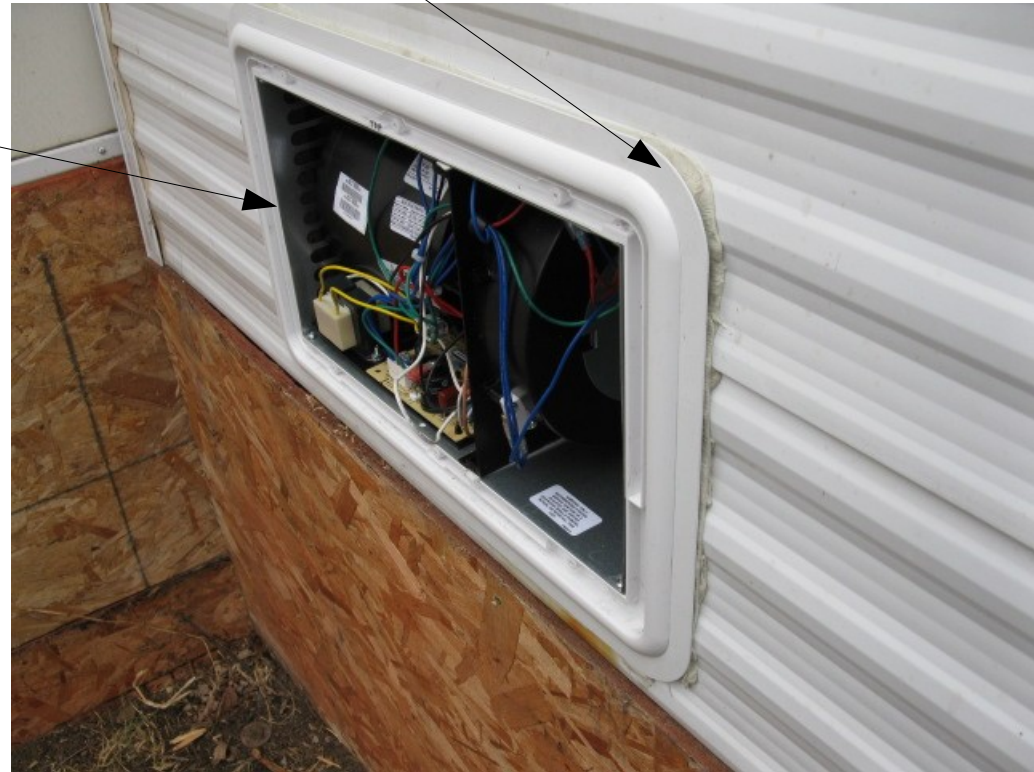
OUTSIDE BEZEL

- Furnace housing extends “into” bezel.
- After adding 32337 discharge kit, both old and new furnace housings are the exact same length.

- 32423 Trim Ring
